NBSIR 87-3642

An Initial Investigation of the Properties and Performance of Magnesium Oxychloride-Based Foam Thermal Insulation

Walter J. Rossiter, Jr.
Paul W. Brown

U.S. DEPARTMENT OF COMMERCE
National Bureau of Standards
Center for Building Technology
Building Materials Division
Gaithersburg, MD 20899

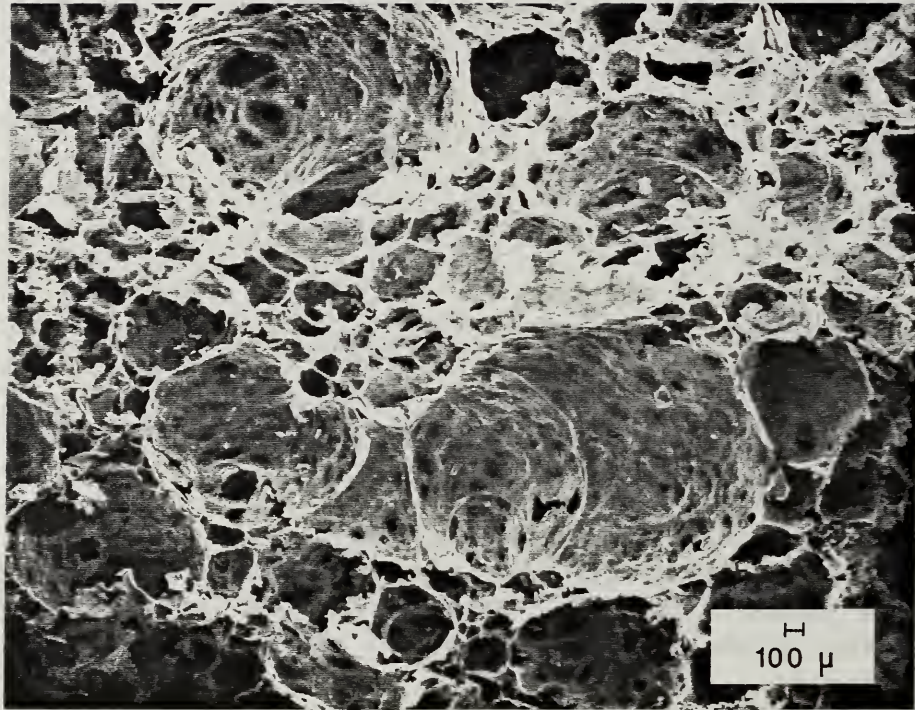
Fig. 1. SEM photomicrograph of a laboratory foam specimen at x20 magnification.

SEM analysis was conducted on two laboratory specimens. The results indicated that the microstructures of the two were generally the same. Fig. 1 shows a SEM photomicrograph taken of a laboratory specimen at x20 magnification. It is evident that the structure of the foam consists of cells that have a large variability in size. Each of the cells was seen to have a number

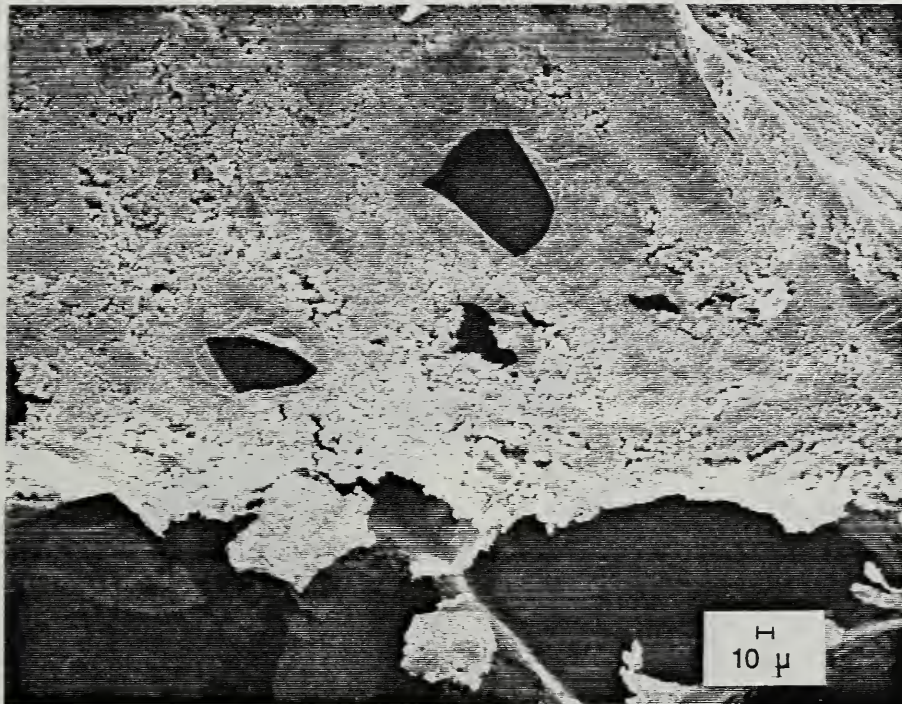
Fig. 2. SEM photomicrograph of a laboratory foam specimen at x200 magnification.

Fig. 2 is a SEM photomicrograph at x200 magnification. Cell windows both with and without membranes are apparent. This figure also shows that the surface of the cells between the windows has a rough or pockmarked texture. In general, this surface roughness was typical of the cellular structure of the laboratory specimens. One exception was a limited area of one specimen in which a cell wall was found to have the appearance of needles.

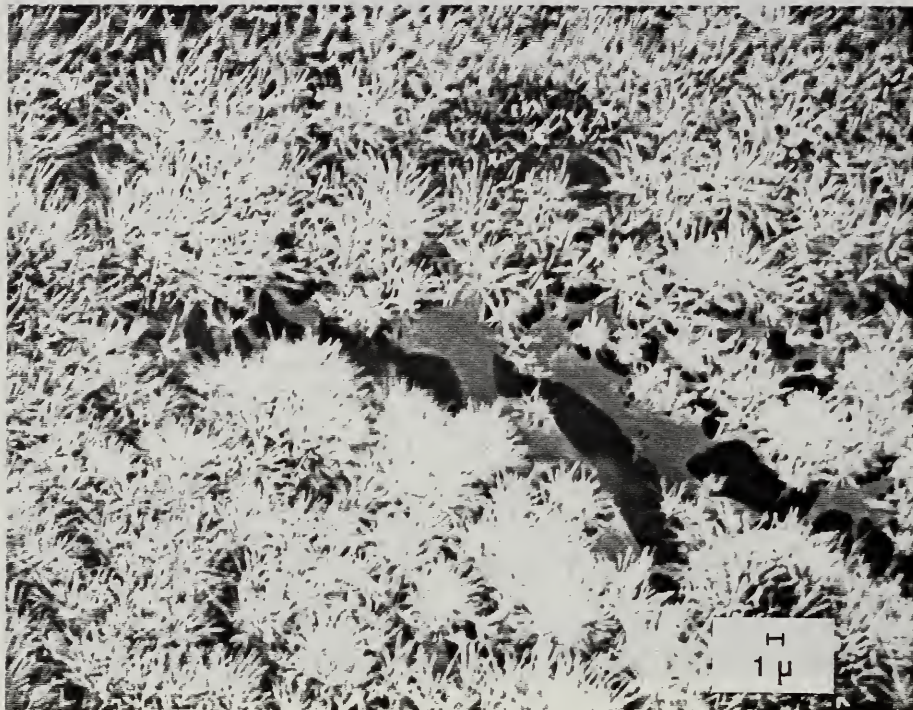
Fig. 3. SEM photomicrograph of a field foam specimen at x2000 magnification. The specimen was removed from the inner side of the wall cavity.

SEM analyses were also performed on two field specimens for comparison with the photomicrographs of the laboratory specimens. As with X-ray diffraction, one field specimen was taken from the vicinity of the outer side of the wall cavity, and the other was taken near the inner side of the wall cavity. At low magnification (e.g., x20-x100), the microstructure of the field specimens appeared to be the same as that of the laboratory specimens. However, higher magnification observations (e.g., x500) of the surfaces of the cells indicated a marked difference between the two field specimens. The microstructure of the specimen from the outer side of the cavity was comparable to that of the laboratory specimens. In contrast, in the case of the field specimen taken from the inner side of the cavity, needles were observed on the

The difference of surface characteristics of the microstructure of the two field specimens, observed by SEM analysis, was consistent with the results of the X-ray diffraction analysis. As discussed, X-ray analysis also showed the laboratory specimens to be essentially identical to the field specimen from the outer side of the cavity; whereas the field specimen from the inner side was different, possibly having formed some chlorocarbonate. The formation of a chlorocarbonate may produce a change in the microstructure that was observed in the SEM analysis.

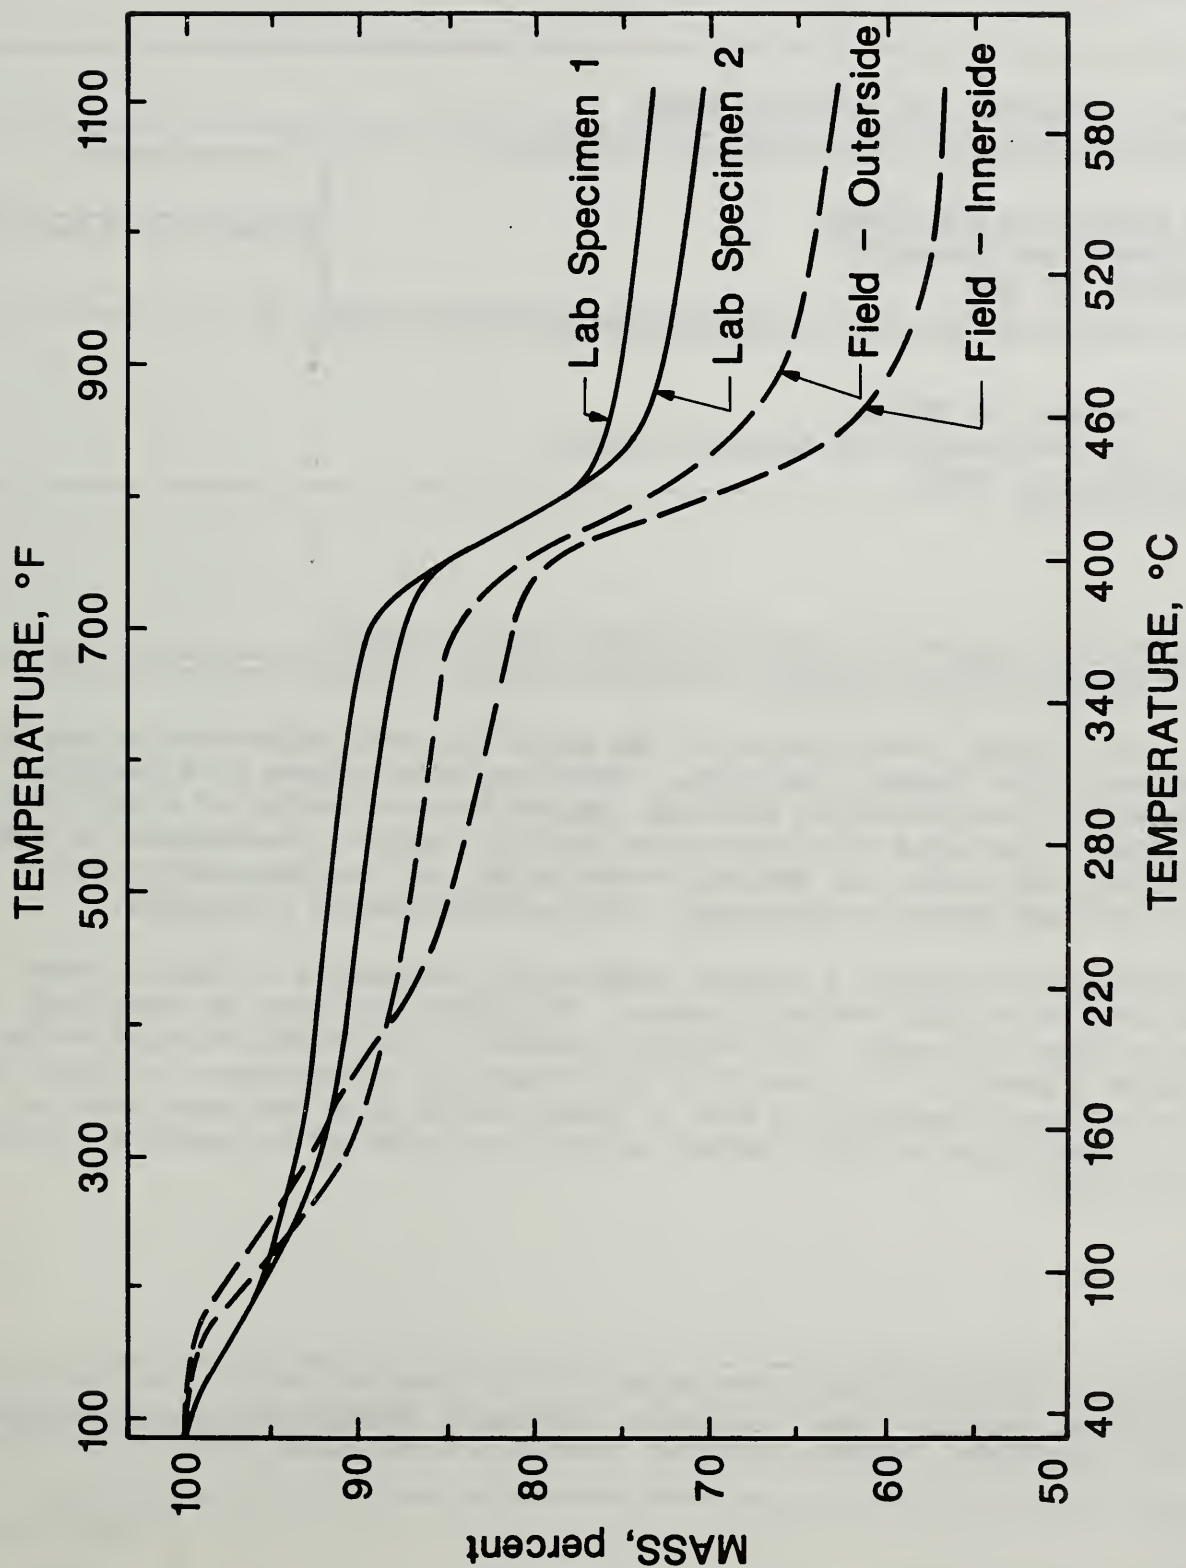
Figure 4. Results of the TG analysis. Specimens were heated in nitrogen gas at 1°C/min (1.8°F/min).

In the low range, the magnesium oxychloride cements underwent dehydration to the same anhydrous phase [10]. The 3-form and 5-form lost about 34 and 27 percent of their mass, respectively when heated to about 175 °C (347 °F). These percents were essentially equal to the theoretical percentage of water of hydration present in each form. At higher temperatures, thermal degradation of the anhydrous phase occurred. The additional loss of mass by heating from about 300 to 460 °C (572 to 860 °F) was about 26 percent for both the 3-form and the 5-form.
